APPENDIX G WATERSHED CONDITIONS

G.2 Recommended Watershed Conservation Practices

G.3 Watershed Rainfall and Flow Records

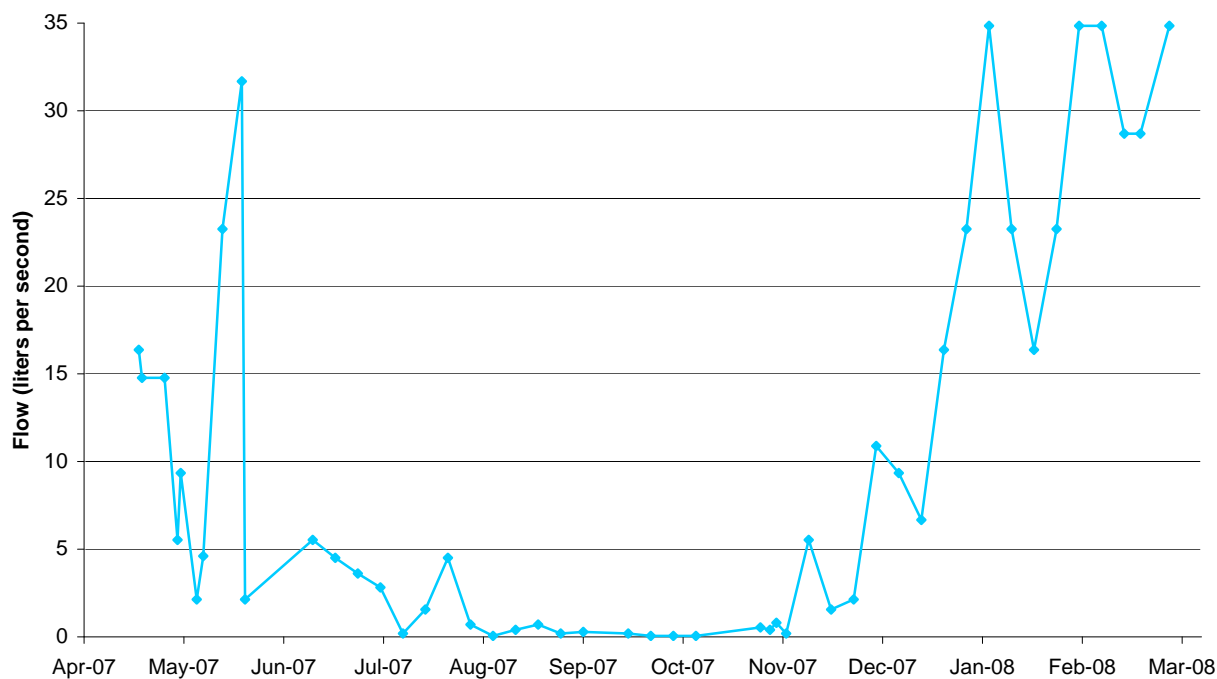
**Instantaneous Flow Observations at Malingua Yacu
EWB H-Flume**

EWB-Denver initiated a program of rainfall and flow measurement in the spring of 2007. Under this program, weekly observations of flow at one flume and rainfall at three gages are made by groups of colegio students. The data are transmitted to EWB for processing. The attached figure summarizes the data collected in this program over a period of approximately 11 months. The student group is to be commended for their continuing support of this program. Continuing maintenance will be needed at the measurement stations to ensure data quality.

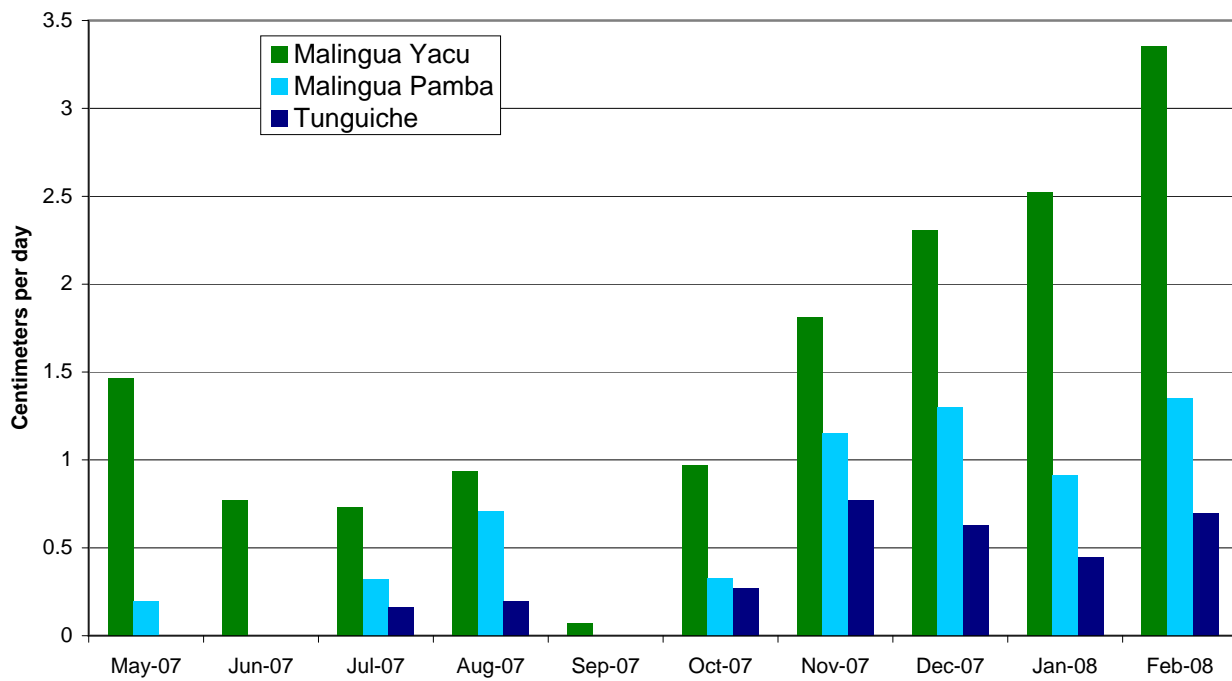
Average Precipitation
